Zenit E series E, EM, ET, 11, 12, 12XP, 122

Foam replacement

Ver 1.0 N.L. 24/05/2022

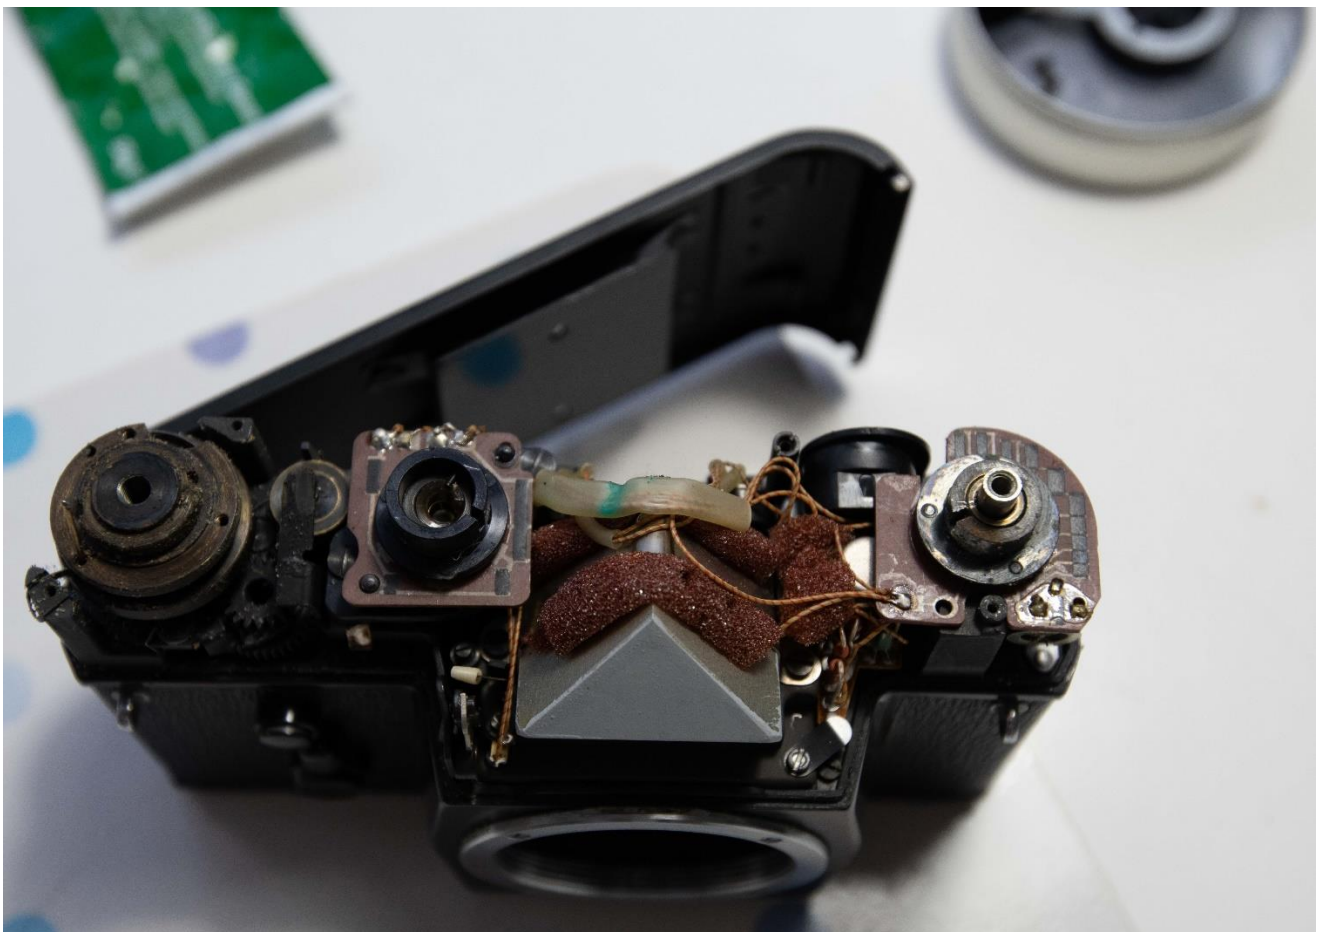
Photo of a 12XP. The brown rotting foam can be seen above and around the prism. It looks ok, but touching it, it turns to a sticky goo.

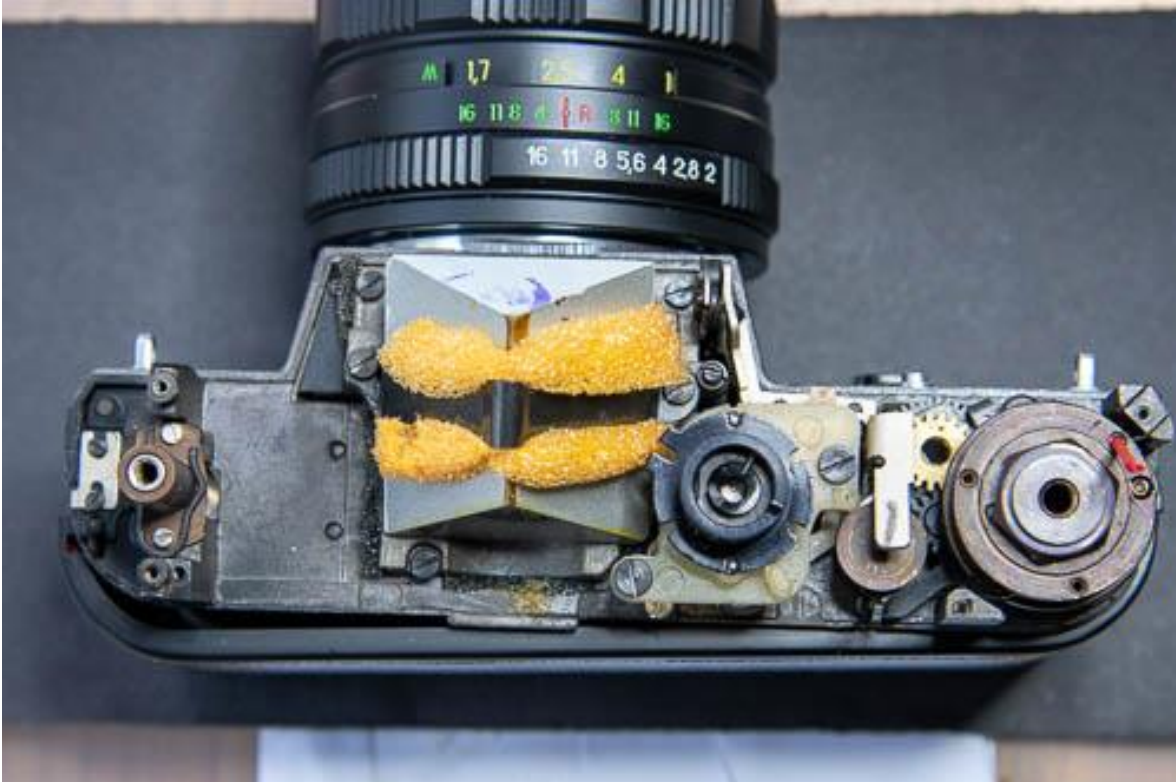
The original foam above the prism & the black light sealing foam to the left. Not much remains of this or the foam below the eyepiece, much of it was stuck to the top. Plastic top ET.

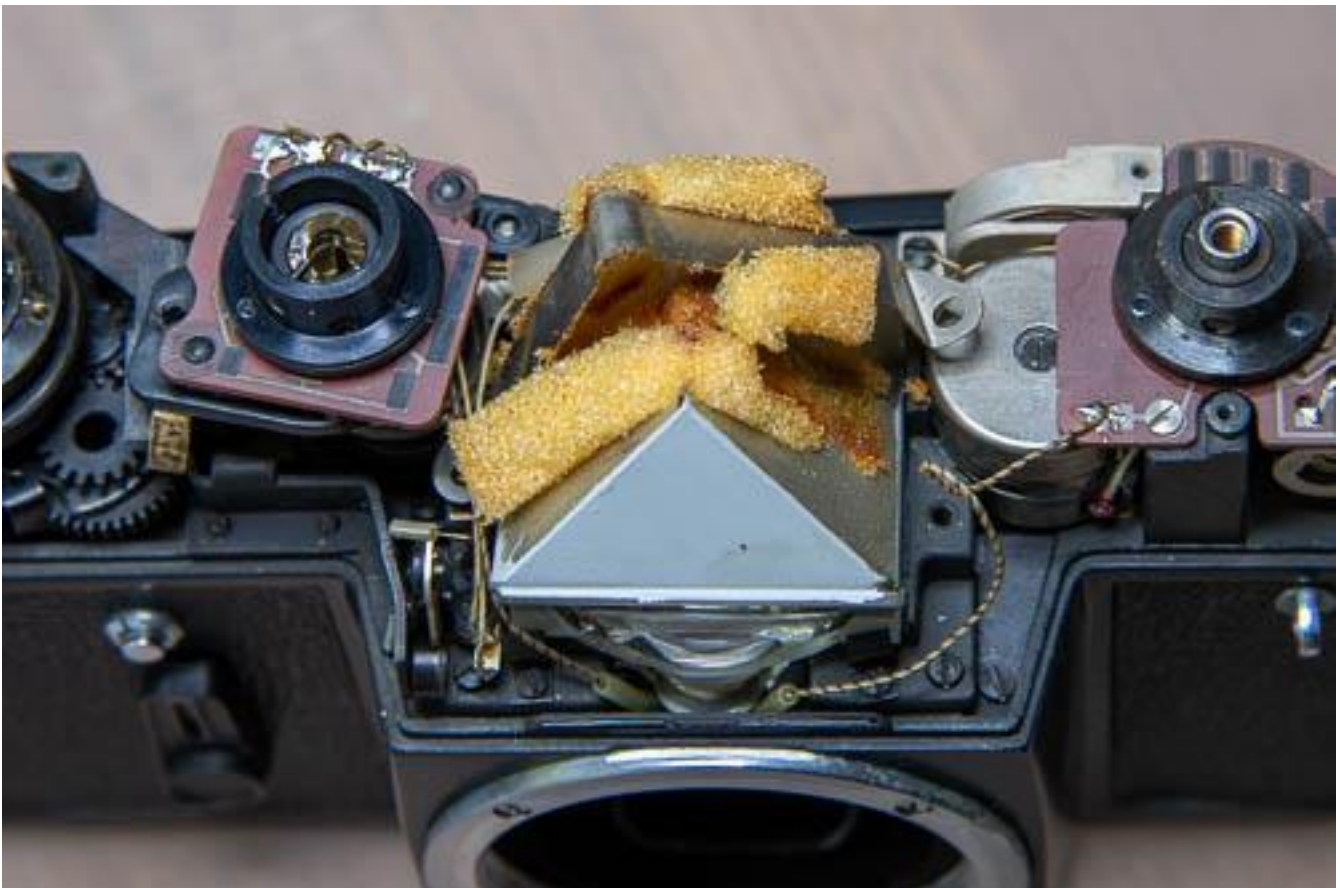
Prism strap being removed from the prism on a Zenit TTL, showing all the rotting foam. Note the shutter speed control has been loosened to aid access. Be careful if you do this, as there are very thin shim washers on top of the drum shaft. Note there is no foam between the light meter and the prism housing on the TTL.

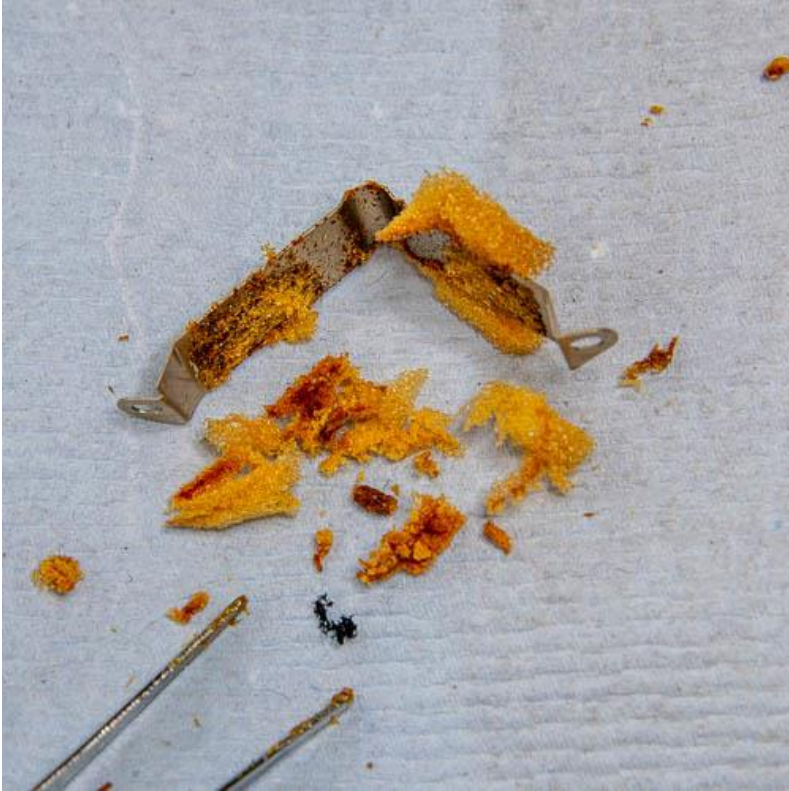
Picking off the sticky foam

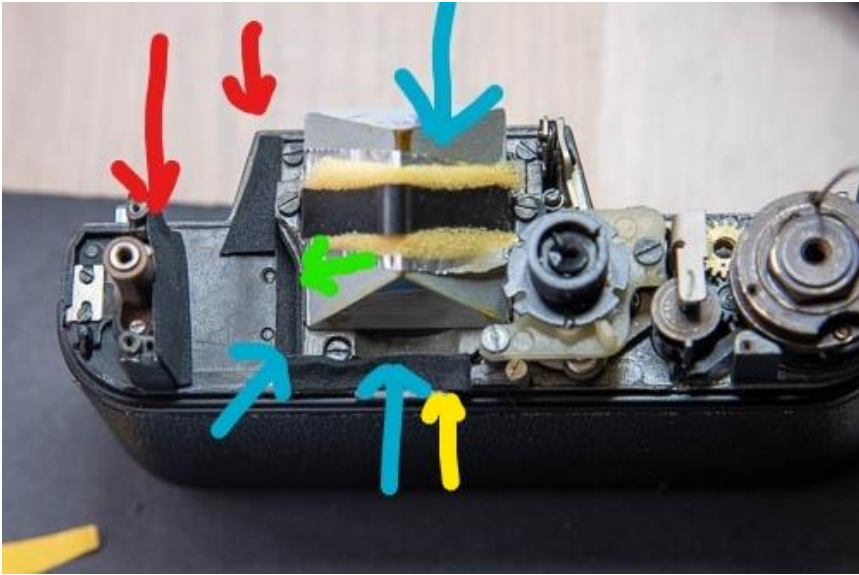
The photograph below shows a plastic top ET, notorious for light leaks.

The blue arrows show where the original foam light seals were replaced with new EPDM.

The red arrows show the additional light seals added.

The green arrows show where light gets into the mirror-box, between the prism & prism housing.

The yellow arrow shows the slight change on this model (plastic topped ET), the casting has been extended to separate the door back seals (these are wool and never need replacing) and the foam under the eyepiece. Most cameras do not have this extrusion, so much care must be taken not to damage the wool back door seal when removing the foam seal that will be stuck to the wool.

Between the top of the prism and the securing strip lives the foam that rots and destroys the prism. The photo shows the foam replaced, with aluminium foil between the new foam and the prism, to avoid direct contact.

There is very little space between the rewind post and the side of the prism for the light meter to sit (on top mounted light meter models).

The EPDM can easily be cut to shape with scissors or a scalpel. Test fit the top when replacing and adding the seals, to ensure they do not foul the light meter.

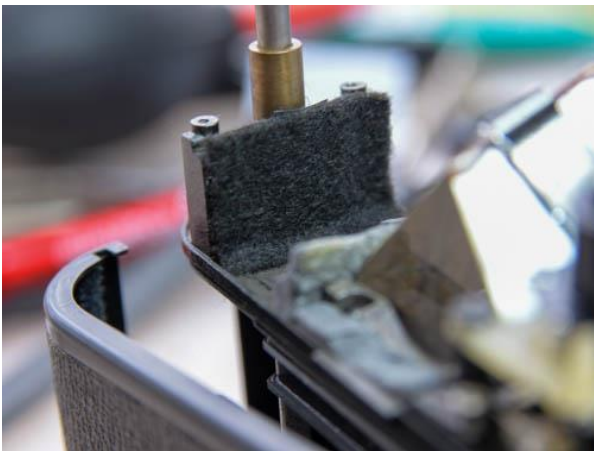
Note the triangular piece of EPDM added to the front of the camera & left of the prism (top red arrow). This blocks the gap between the cast chassis and the pressed steel light baffle. In the same place on the other side of the prism, lives the lens diaphragm lever, which go into the mirror box, so this side cannot be blocked, more on this later.

Self-adhesive 1.5mm EPDM dense foam was added to the side of the rewind post. Newer cameras are hollow there, which lets light into the camera back. 1mm thick would be better here.

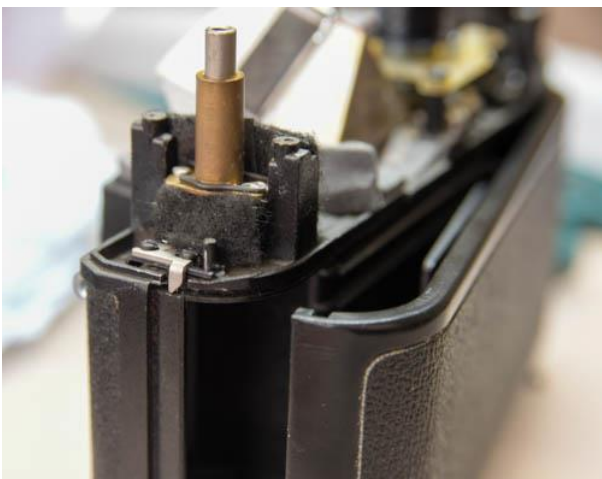
Cut a slot in the foam this side, to allow the door lock to lift.

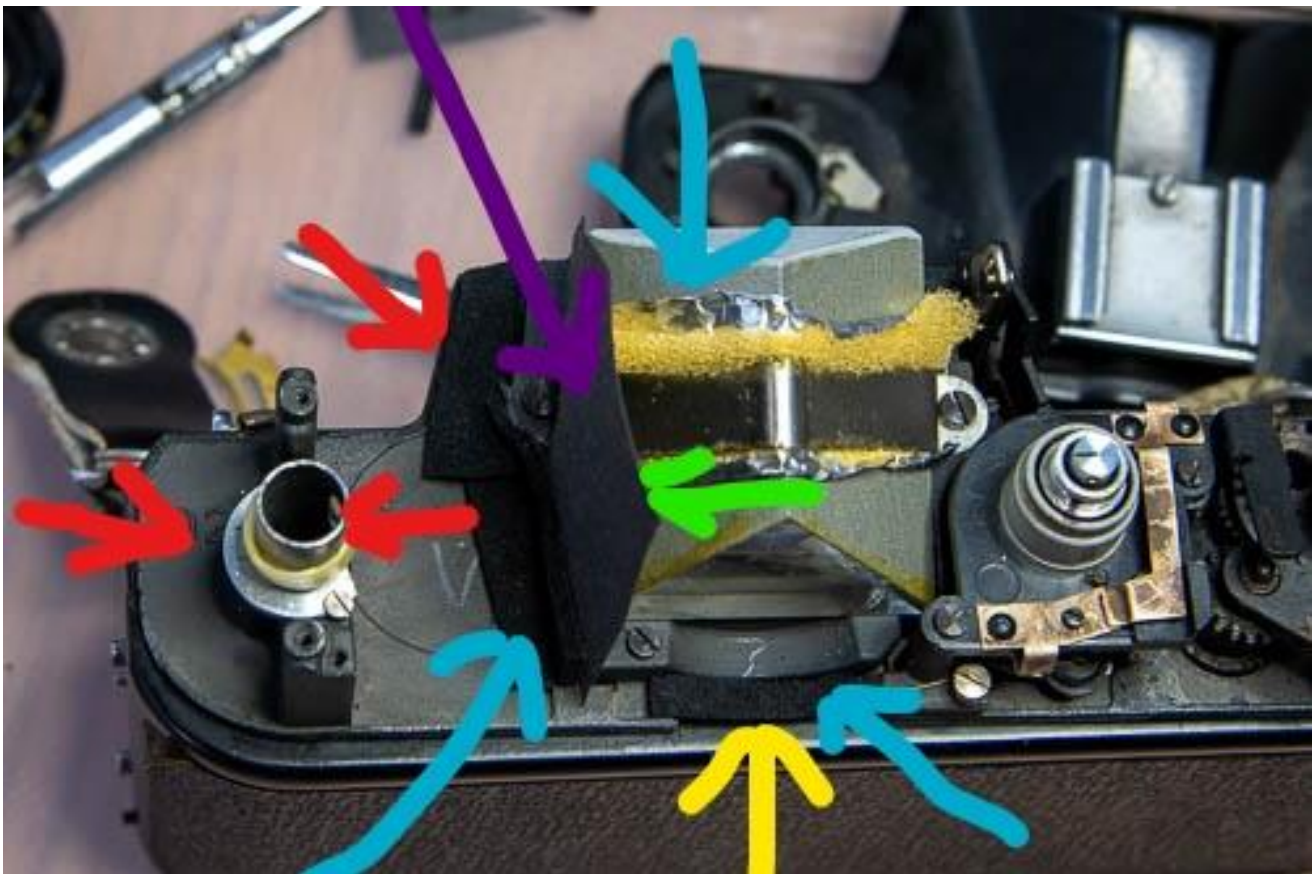
A cardboard baffle was made and secured under the prism retaining strip screw and stuck to the EPDM foam (purple arrow). It was deliberately not affixed to the prism. (Paranoia about damaging the silvering with adhesives).

This stops light getting down the side of the prism (green arrow). It also blocks light getting to the far side of the prism and down the diaphragm lever hole.

Note:- This is an addition to the factory light sealing. Only needed on models with a top mounted light meter and was added to a plastic topped ET, which are notorious for light leaks, so every possible source was sealed.

New EPDM foam can be seen below where the eyepiece will sit.

The new prism foam & foil can be seen.

This is a Zenit EM. 1.5mm EPDM sheet has been used for the light sealing. Purple arrow shows the additional light baffle.

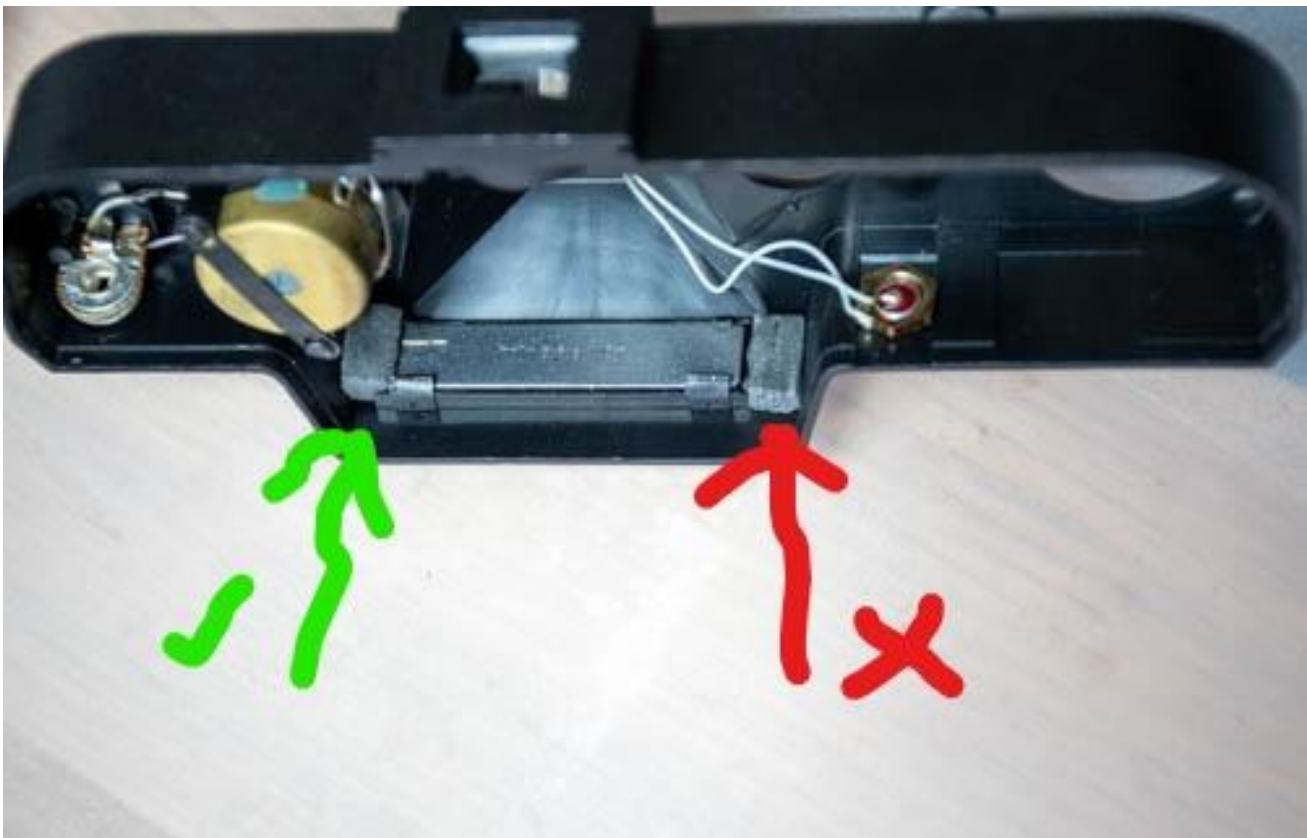
This photo shows the top of the Zenit, a plastic ET. The light-meter can be seen (gold colour) and it sits very low. Check in the roof and around the eyepiece for bits of rotting foam or goo & remove it all.

For models with a front mounted light sensor, shine a torch onto and to the left and right of it, whilst observing by looking inside. On this model, much light could get in either side of the light-meter, shown by the green & red arrows.

EPDM foam was put where the green arrow is, to block the light. Be careful as this is also where the wires connect to the light-sensor. This blocked the light 100%

EPDM foam was added to the other side (red arrow) but on assembly it was found to foul the diaphragm lever (remember the big hole there that goes into the front of the camera)?

The foam (red arrow) was substituted for black vinyl tape (similar to electricians tape, but does not shrink & go sticky) and when rechecked, also blocked the light 100%

1.5mm EPDM sheet would probably be ok here.

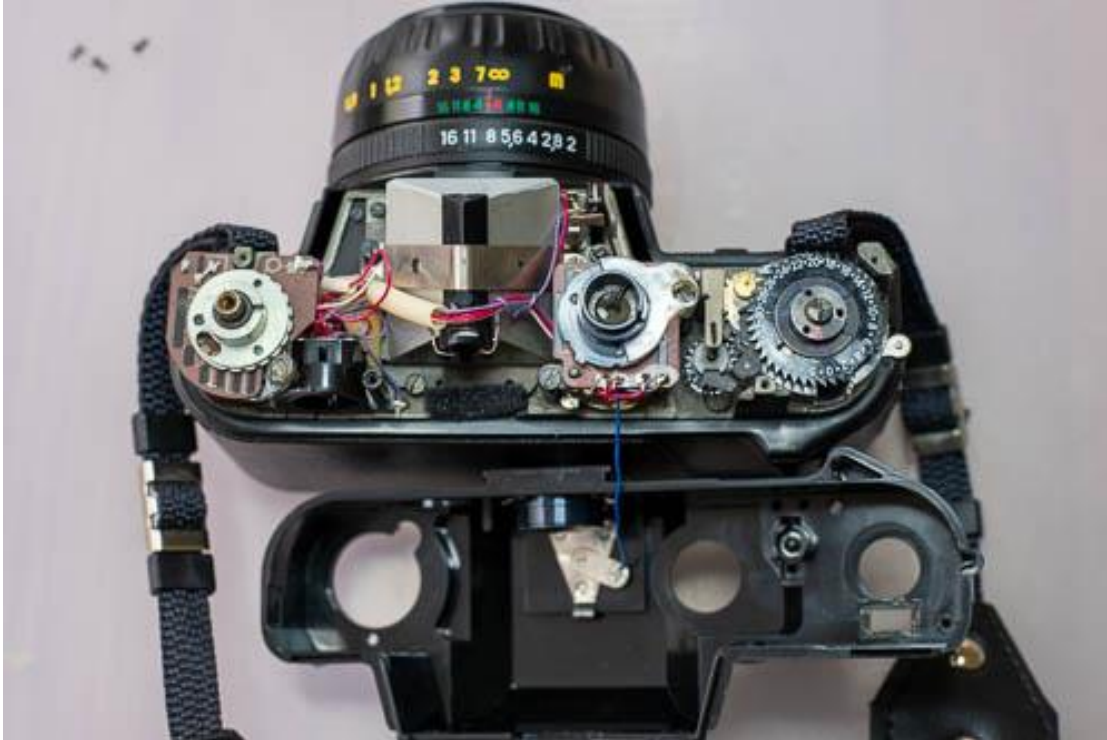
Late model 122. The prism foam has been replaced by a black plastic spacer and the strap screws have springs to allow for expansion.

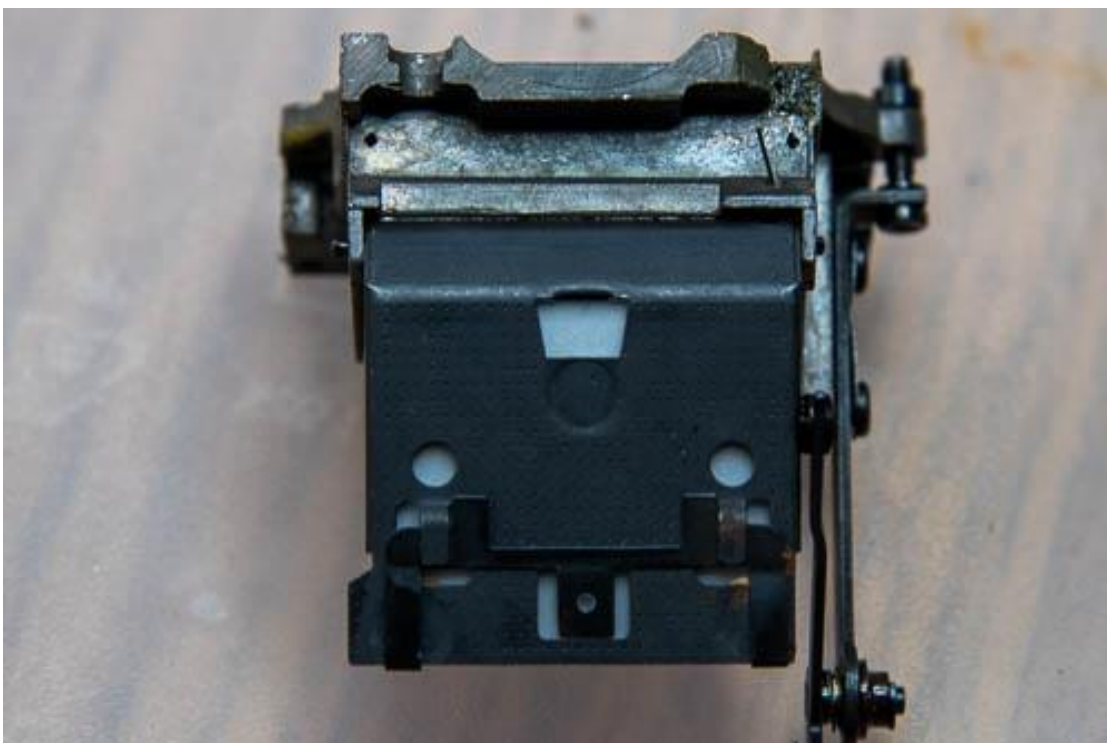
This is the mirror mech taken from the plastic topped ET. As this model is notorious for light leaks, every single possibility was addressed. Here it can be seen that there are holes in the metal tray. Light getting into the eyepiece can find it's way through these holes. Older models had a very thin leatherette on the underside of the mirror. I have been unable to source any similar material.

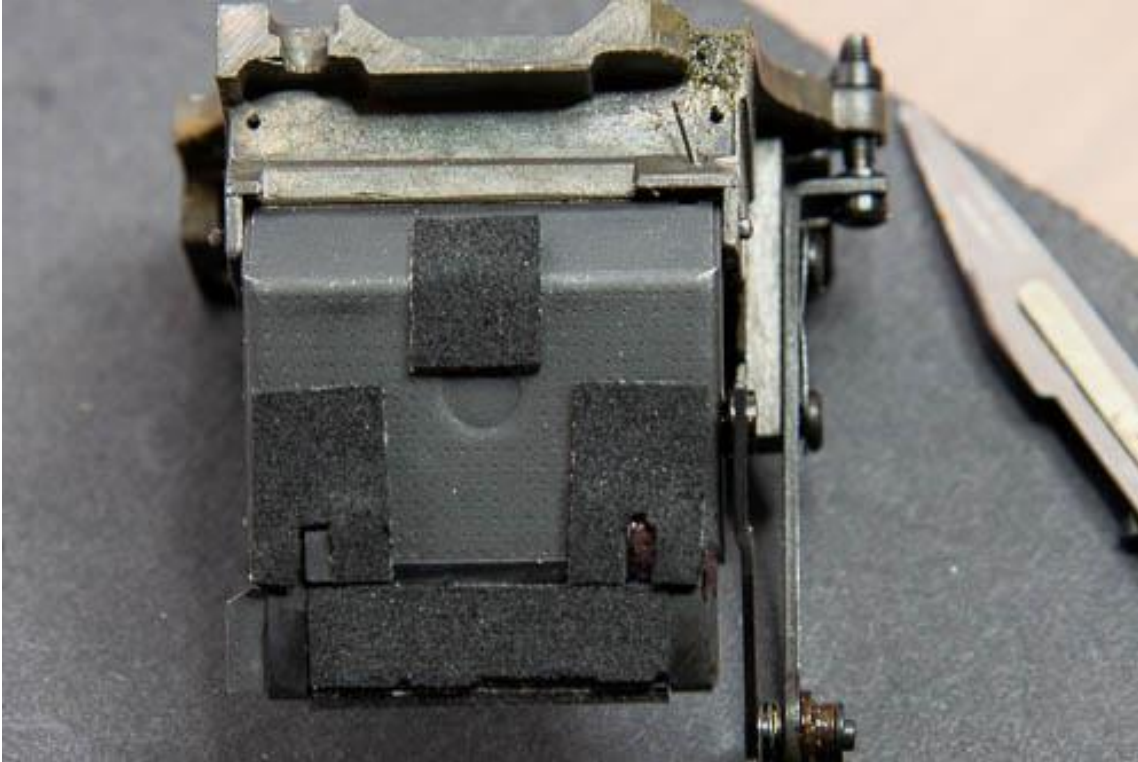
The holes were covered with 1mm EPDM, which was the thinnest suitable material I could find. The cut-outs in the EPDM were to avoid the EPDM possibly getting into the picture.

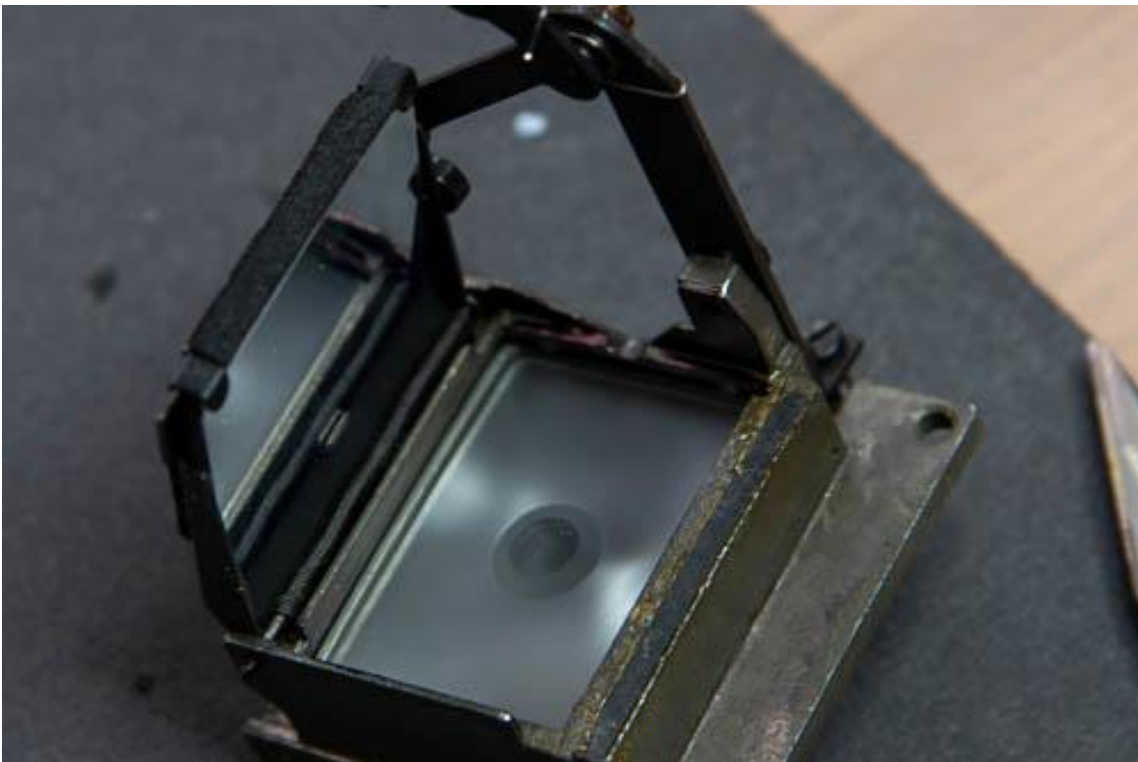
The front edge of the mirror has no sealing (older models had a lip on the metal mirror tray) so a 1mm piece of EPDM was added.

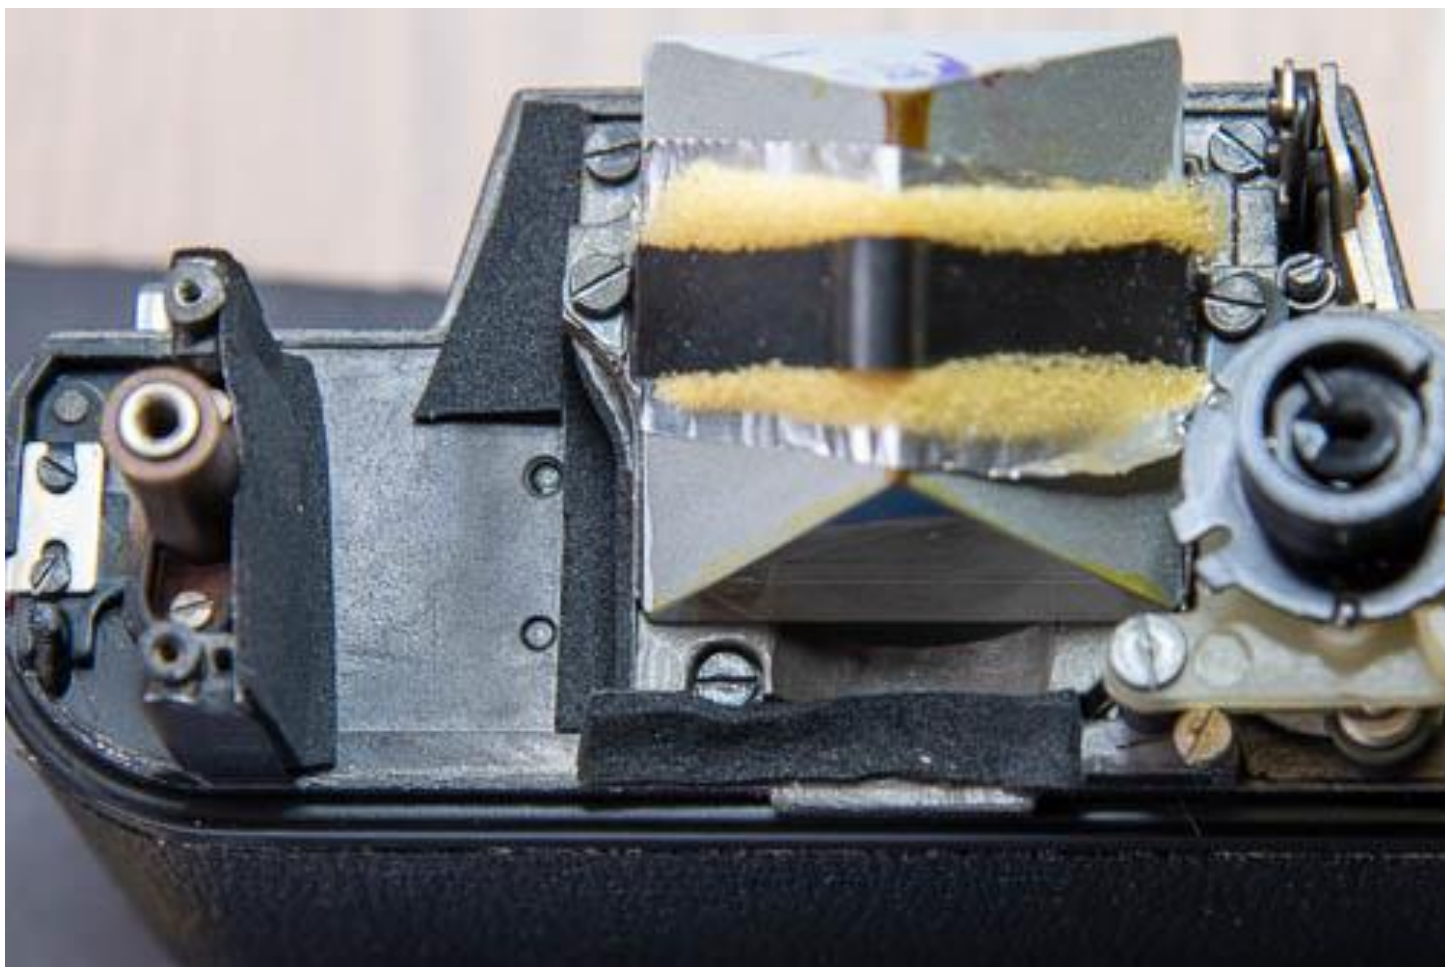
A larger picture showing new prism foam & foil and light sealing added to a plastic topped Zenit ET.
