## SP-445

### Mold line

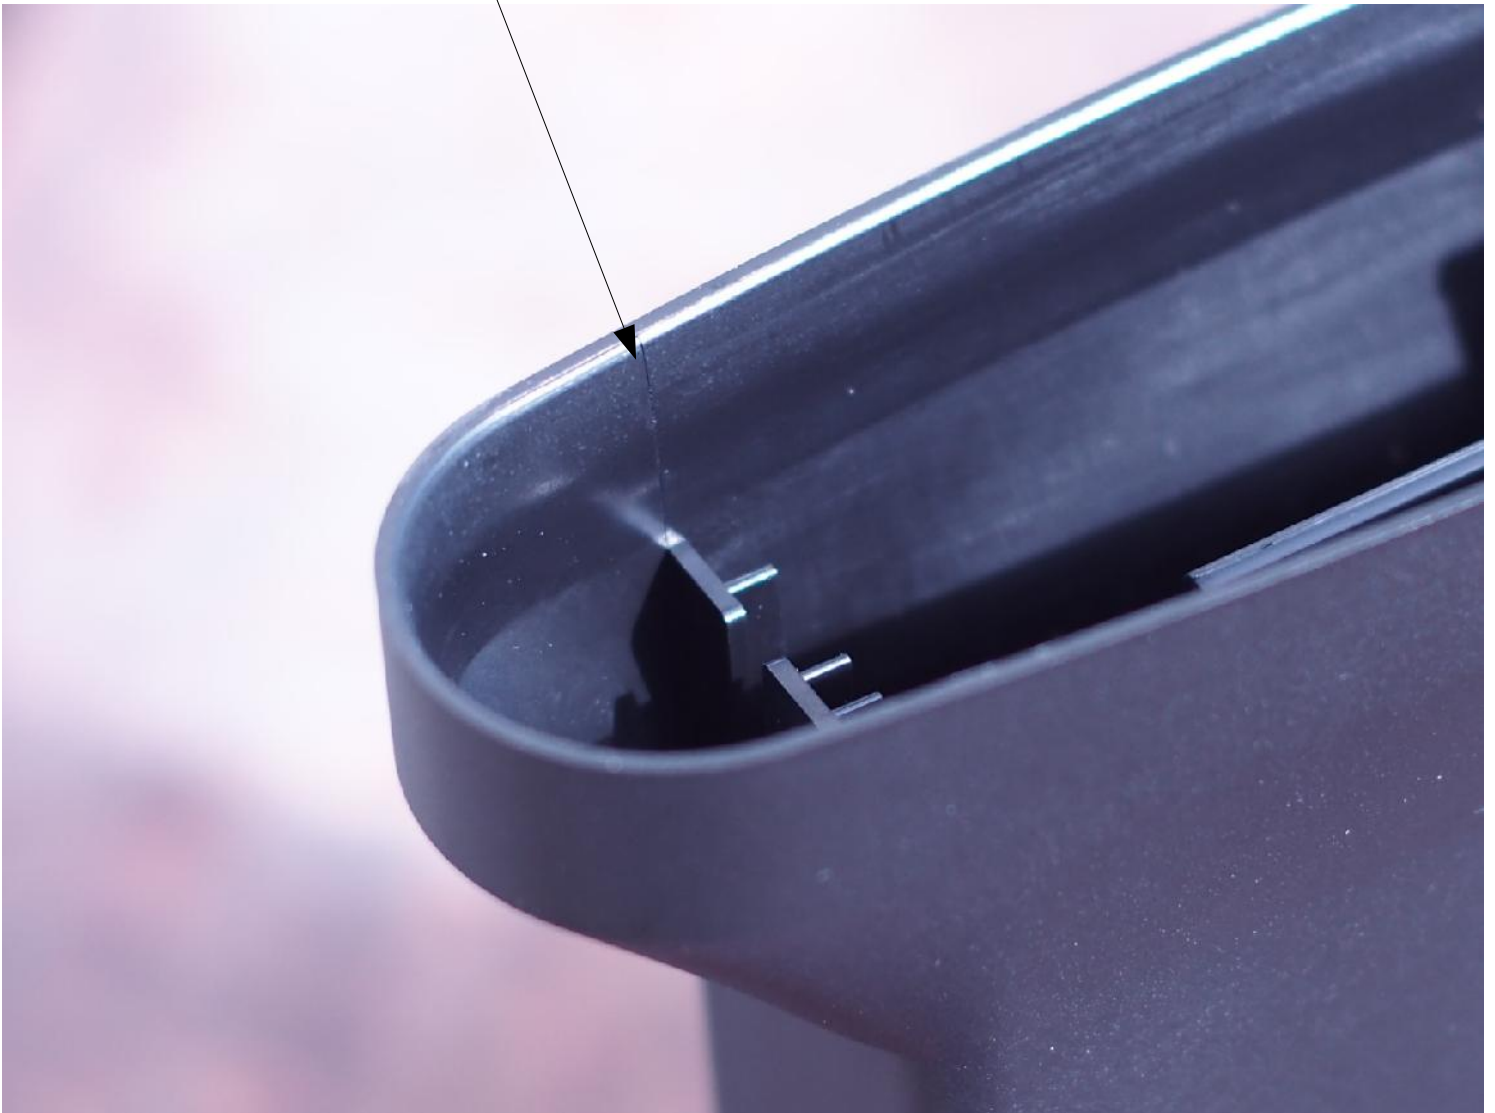
A few tanks have noticeable parting lines from the mold, (on the inside sealing surface as shown below). The line on the beveled surface (top half) doesn't affect sealing but the line on the bottom surface might, since that is where the O-ring "seats". You can *gently* polish down with 320 or 400 grit wet/dry sandpaper & water. Be careful, it doesn't take much pressure to remove material. Note that it doesn't have to be perfectly smooth to seal well.
